Dod Farm, Hawick, Scottish Borders

Archaeological Survey

Report No 30
Project ID: CA030

Archaeological survey
on behalf of
Scottish Woodlands

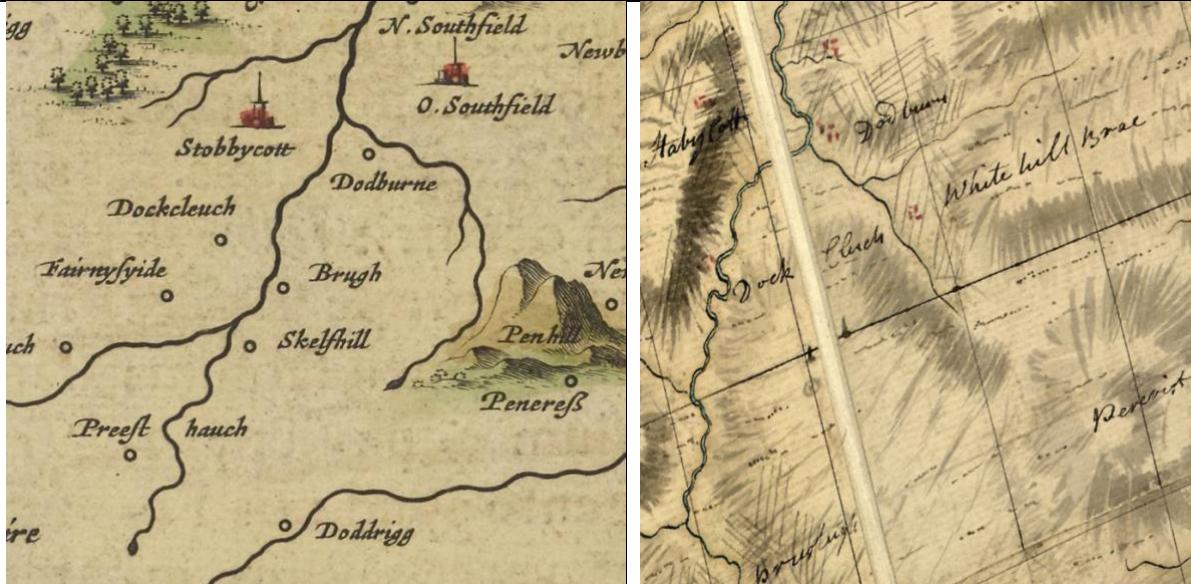
Illus. 2: 'Dodburne' on Blaeu's Atlas (17th century)

Historic maps were initially consulted. Blaeu's Atlas of Teviotdale (1662-5), based on Timothy Pont's 16th century manuscript map, depicts a settlement at 'Dodburne', near the junction with the Allan Water (Illus. 2). This place name presumably relates to Dodburne Farm, which lies north of Dod farm. Blaeu depicts the countryside to the south of 'Dodburne' as featureless. William Roy's mid-18th century Military Survey of Scotland also depicts 'Dodburne' surrounded by cross-hatching, suggesting rig and furrow cultivation, and a settlement called 'Whitehill Brae' to the south-east (Illus. 3).

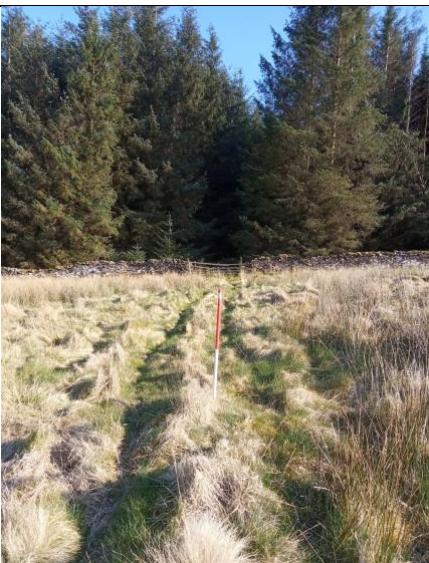
This track is marked on the 1st edition OS map as 'Thieves Road' and comprises a terrace and a worn hollow. Its name associates it with the Border reivers and it is therefore presumed to be medieval in date. It currently passes to the west of Dod Farm and travels uphill, where it survives as a track with a gravel surface and a bank on the downhill side. This track has been designated as an area of interest (HER) by the Borders archaeologist. Its route is followed by several 19th century walls before it passes into a neighbouring forest plantation in the south. The 1st edition OS map shows the track exiting about 20m south-west of the contemporary track (Illus.

6). It is likely that, as a track used over several centuries, it has meandered slightly in places, although the main route has still been followed. The designated HER follows the route as shown on the 1st edition OS. The last 50m of the contemporary track is thus not designated in the HER, but exists as a slight hollow 3m wide.

<i>Illus. 6: Modern route of the Thieves Road entering plantation in the south (Site 1)</i>	<i>Illus. 7: Prehistoric cairn (Site 2)</i>

Mitigation: A buffer zone of 5m to either side of the original route of the Thieves Road should be maintained. Ensure that the last 50 m of the original route (that is not currently within the designated section of the HER, but has been confirmed to exist on the ground) is included within the buffer zone.

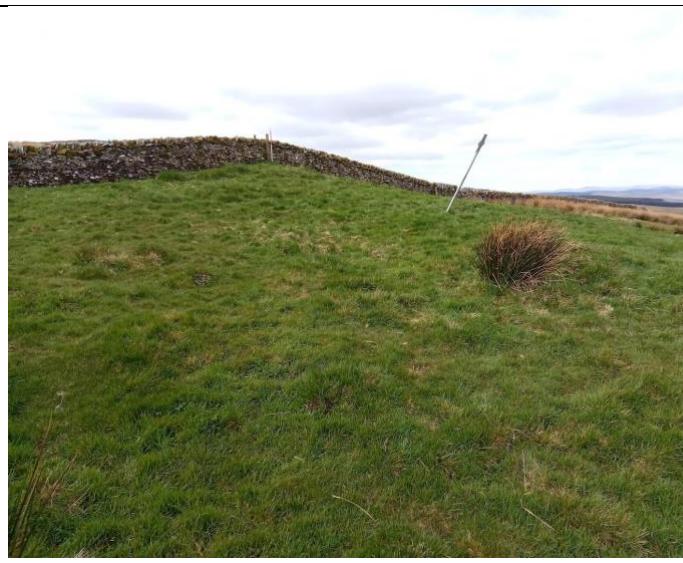
A low cairn was described in 1963 as being 19ft in diameter with three low banks. It has been designated a Scheduled Ancient Monument and is protected by a square Scheduled Area. By 1979 the banks were described as 'poorly defined' and the cairn is currently very low and the 'banks' appear more like cord rig (Illus. 7 & Site 3).

Mitigation: The Scheduled Area should be given a buffer zone of 10m and no work that might damage the monument should be undertaken within the Scheduled Area.

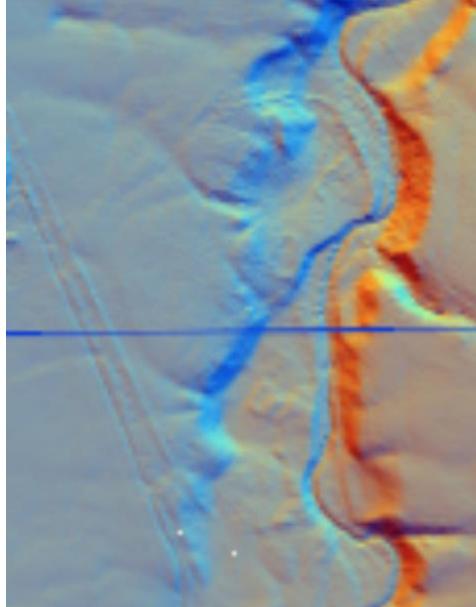
There are visible foundations of at least two rectangular stone-built structures within the mature trees of the Garden Plantation. These structures occupy two terraces beside the Dod Burn and it is possible that other buildings also once existed here. Although not Scheduled or Designated in the HER, this group of buildings is of archaeological significance because of its probable medieval date. Sites 42 and 43 relate to a drystone wall and earth bank that mark the north and south extents of the Garden Plantation. These features are clear on LiDAR images and on the ground (Illus. 8 & 9). The grid reference in the archaeological record (Canmore) is misleading because it suggests that the site of the castle lies 50m west of where the buildings can clearly be seen.

<i>Illus. 8: Site 4, medieval Pele house and outhouses</i>	<i>Illus. 9: Site 4, southern structure from the south with encroaching young trees</i>

Mitigation: The Garden Plantation should be avoided by any new works and should have a buffer zone of 5m from its boundary. Young trees are currently encroaching on the southern structure and should be removed to prevent further damage to the structure.

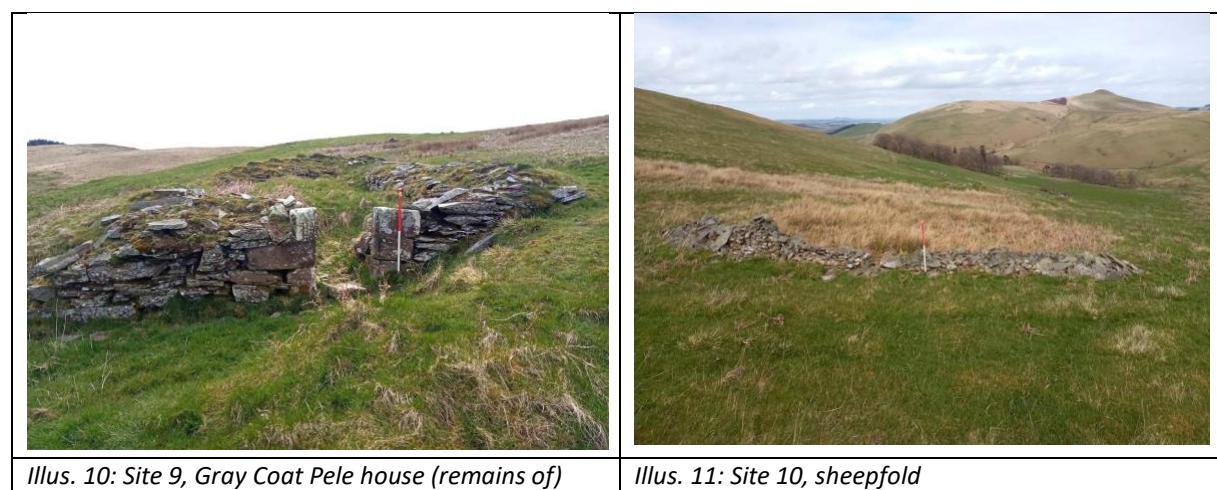
The ruins of Gray Coat Pele house survive as a drystone, rectangular structure, thought to be of 16th century date (RCAHMS 1956; THAS 1967; Wood 1969; Scot & Wood 1980) (Illus. 10). It is a Scheduled Ancient Monument. A covered drain and two other structures have also been identified nearby (Sites 29, 30 & 31), but lie outside the Scheduled Area.

A 19th century circular sheepfold is marked on the 1st edition OS map. It is currently visible as a partly collapsed drystone wall measuring c. 11m in diameter and up to 0.9m high (Illus. 11).

Mitigation: A buffer zone of at least 10m should be left outside the Scheduled Area. It is suggested that the whole area designated in the HER, which is centred on Site 11, is avoided by any future works, as this would also protect the two outer structures.

Mitigation: A buffer zone of 5m from the wall is suggested.

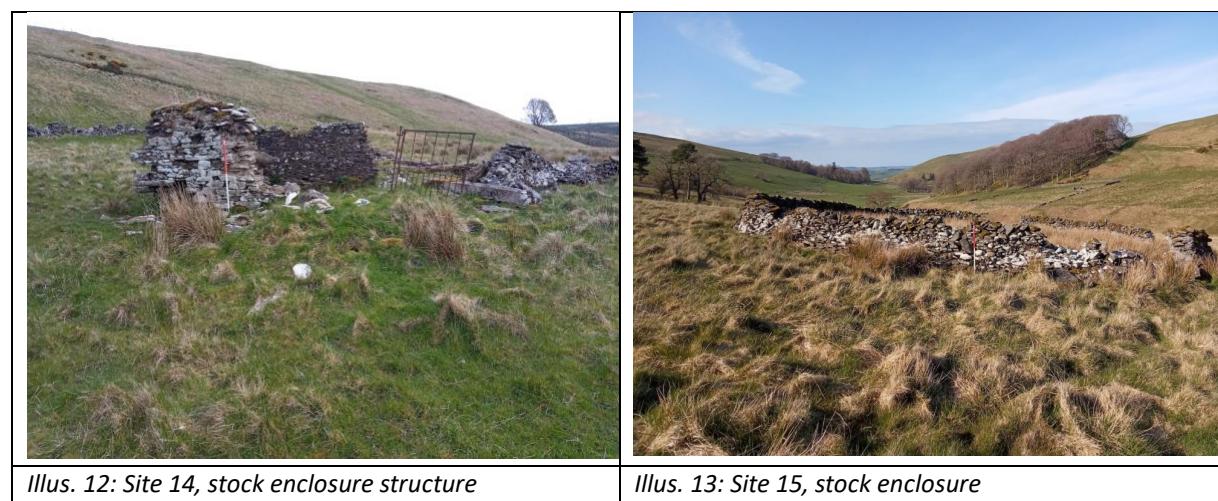
A circular drystone sheepfold is depicted on the 1st edition OS map south-east of Craw Wood. The walls have collapsed in places around its circumference, but survive to a maximum height of c.1.0m (Illus. 13).

Mitigation: A buffer zone of 5m should be left outside the sheepfold.

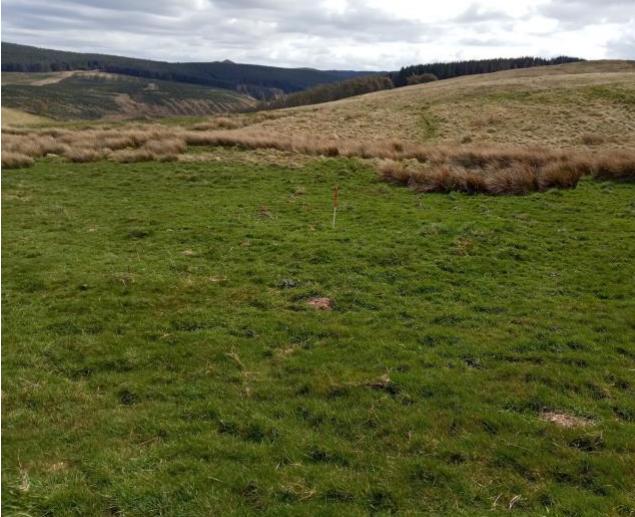
Low earth banks forming an oval feature were located about 100m south-west of the sheepfold (Site 10) and near the Catrail linear feature (Site 12) (see Illus. 14 & 15). This was interpreted as a shieling hut with an external annex. The internal measurements of the hut are 5m by 3m with banks spread c.1.5m wide. Overall,

<i>Illus. 14: Site 24, shieling hut from the north-west. The Catrail (Site 26) lies along the edge of the reeds behind</i>	<i>Illus. 15: Sites 23 & 24, shieling hut & ditch (LiDAR)</i>

Mitigation: A buffer zone of 5m should be kept around the shieling hut.

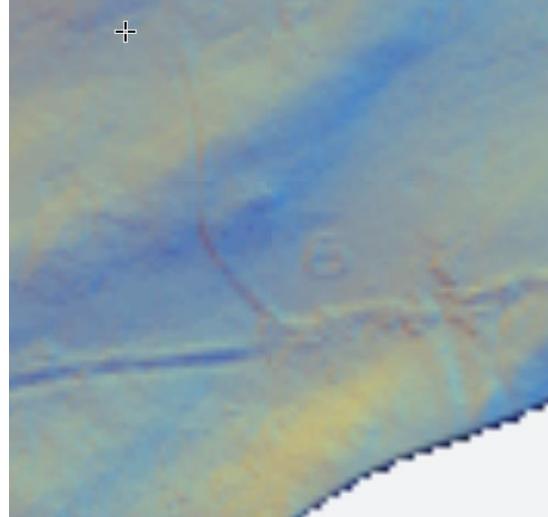
A curving ditch 0.10m deep with a bank 2m wide and 0.15m high was recorded. This feature provides drainage for an area to the east, which is occupied by the low remains of a shieling hut (Site 24).

Mitigation: A buffer zone of 3m to either side of the drain is suggested.

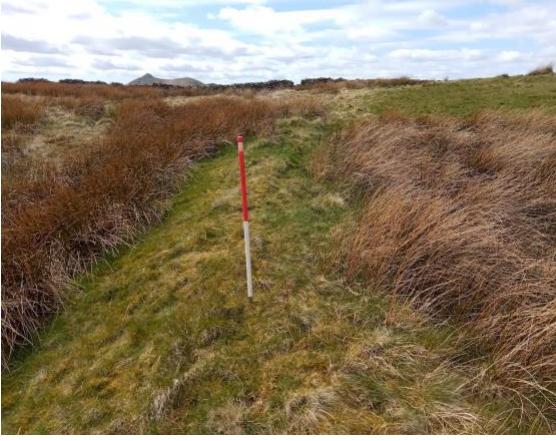
The Catrail linear earthwork is visible to the west of the Thieves Road where it is about 2m to 3m wide and 0.4m high (see Illus. 16). The ditch is about 2.0m wide and 0.4m deep. The linear earthwork extends beyond the property boundary to the west and continues downslope to the east (see Site 12). It has been disturbed by other banks and fades away in the vicinity of the Thieves Road. It is clearly visible in LiDAR images (Illus. 17).

<i>Illus. 16: Site 26, the Catrail from the east</i>	<i>Illus. 17: Site 26, the Catrail (LiDAR)</i>

Mitigation: A buffer zone of 3m should be left unplanted to either side of the Catrail. Part of the Catrail lies within the HER surrounding Sites 9, 10, & 11 (the tower, sheep fold and cord rig).

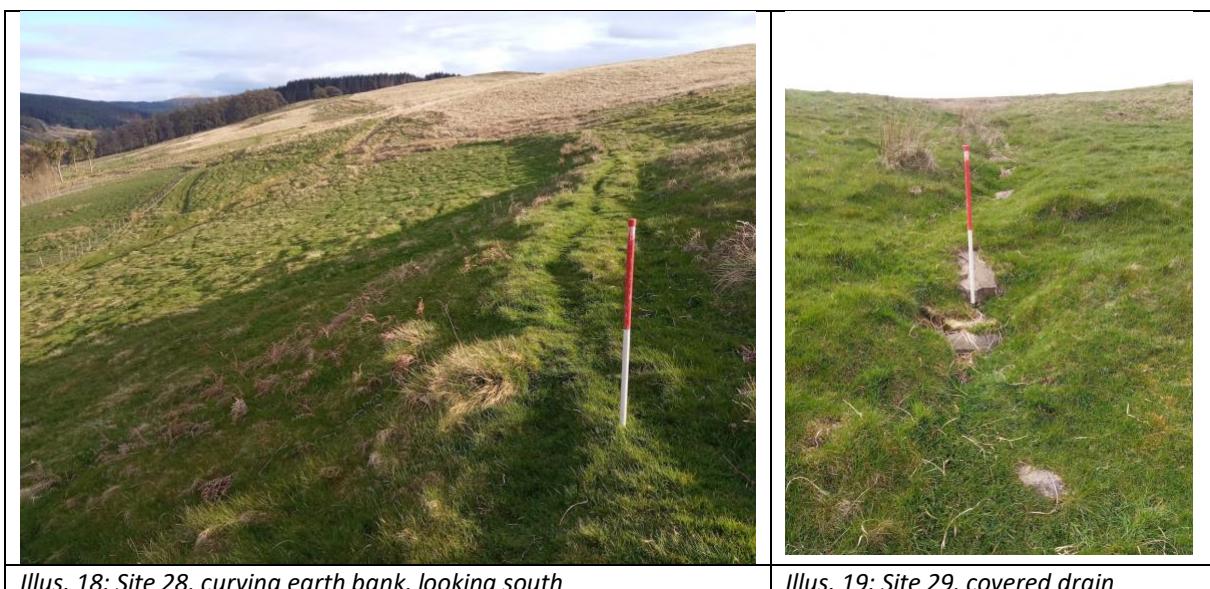
An earth bank about 1.5m wide and 0.5m high curves around, south of the Catrail. It has been used as a path (Illus. 18).

A covered drain (cundy) aligned east-west and heading downhill, was located about 7m south of the Pele house (Site 9) (Illus. 19). This is likely to be 16th century in date, associated with occupation of the Pele house.

Mitigation: A buffer zone of 3m should be left unplanted to either side of the bank.

Mitigation: Much of this feature lies within the HER designated area around Site 11. A buffer zone of 3m is suggested on either side of the feature outside this area.

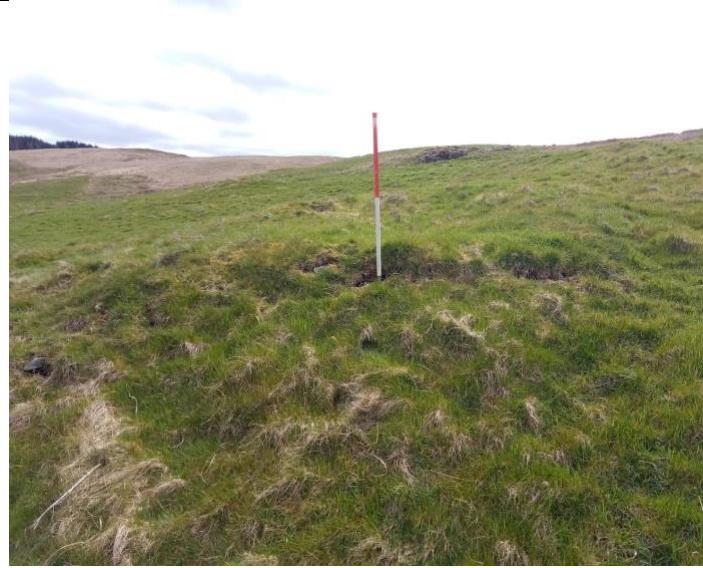
A rectangular structure measuring 8m by 3m, consisting of grass-covered banks with stones visible in the north gable, was located about 30m north-east of the Pele house. This structure is likely to be pre-improvement in date, broadly contemporary with the Pele house (Illus. 20 & 21).

<p><i>Illus. 20: Sites 9, 10, 11, 23, 24, 30, 31 & 33 (LiDAR)</i></p>	<p><i>Illus. 21: Site 31, north gable of rectangular structure</i></p>

Mitigation: This area lies just within the HER designated area around Site 11. It is suggested that a new area of interest is created, centred on the tower (Site 9), that protects this feature (shaded blue).

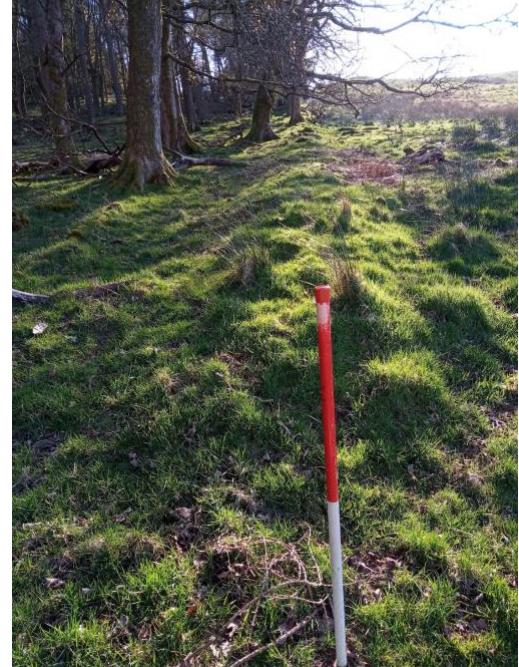
<p><i>Illus. 22: Site 36, earth bank around Young Wood</i></p>	<p><i>Illus. 23: Site 38, D-shaped enclosure (LiDAR)</i></p>

Mitigation: Young Wood is part of a Designed Landscape and should be enhanced or preserved. A buffer zone of

3m should be left unplanted outside the bank.

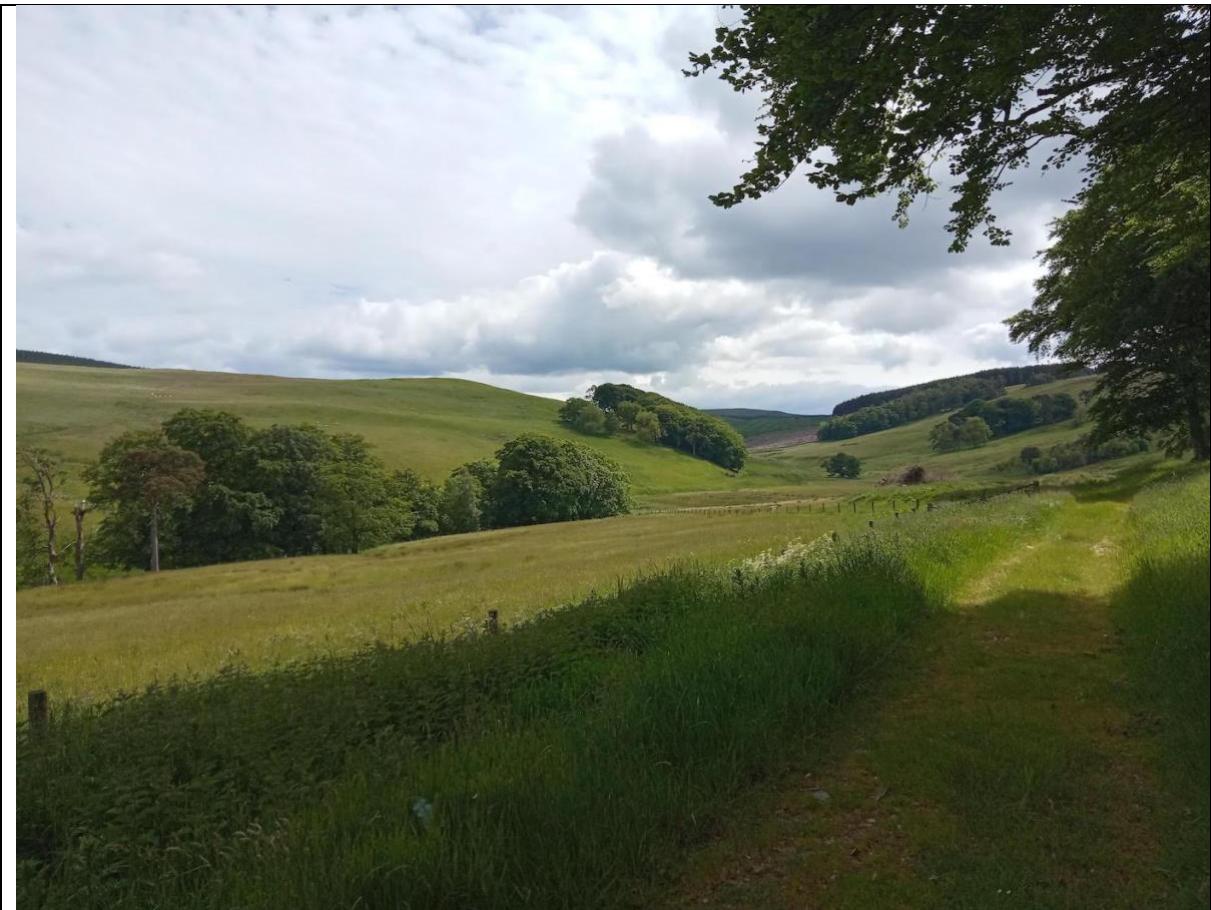
A Designed Landscape extends across much of the central area of the property (Illus. 1 & 24). It consists of enclosed areas of mixed woodland of at least mid-19th century date, but possibly earlier. Some of the woodland is named on the 1st edition OS map and all are named on the 2nd edition map (see also Site 44).

Illus. 24: Designed Landscape. Garden Plantation, Heather Wood & Crow Wood seen from the shade of Brae Plantation

Mitigation: The Priesthaugh Designed Landscape is of local significance. It does not preclude further planting in the area, but new planting could possibly reflect, augment or renew the design. It is suggested that the outer banks have a buffer zone of 3m.
